Performance of Interior Space for Historical and Spatial Transformation; Refunctioning of Kula Sungur Bey Bath

Dr. Özlem ATALAN

Manisa Celal Bayar Üniversitesi - Manisa

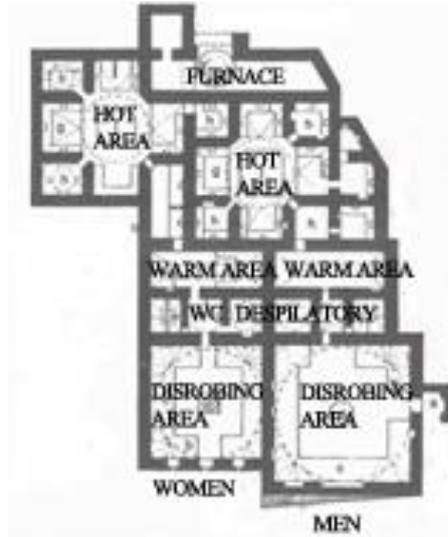
Different typology of hot area plans is created with a heated marble slab, recesses and individual cubicles. The most common cross plan type has four recesses and individual cubicles at the corner in the Turkish bath architecture. Each section has about 20-30 cm marble seats (bench) and a small basin (kurnas) on them.

Figure1. Scheme of Classical Ottoman Period Baths¹⁴

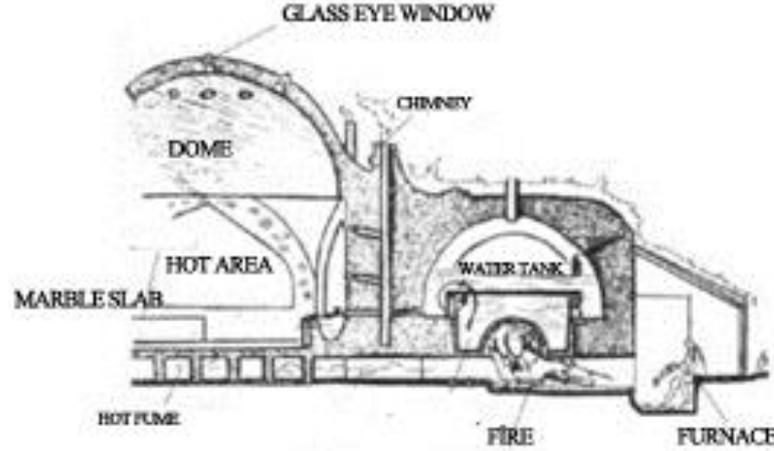
In the last section was a furnace (külhan) where the water was heated. This section was connected to the stokehole of a Turkish bath (cehenemlik) below. The heating of the water was provided by the fire which burned in the furnace under the water reservoir. The heated water was supplied to the various places of the bath with the clay tiles, made of terracotta, located in the walls. There was a space (cehenemlik) under the warm area and hot area. This space was formed with arches which were sat on short columns. The fire fumes of furnace were circulated in this space. Bath building was heated. At the same time, the walls of the bath were heated with chimneys in the walls. Fumes were thrown out with chimneys.

Figure 2. Turkish bath heating system¹⁵

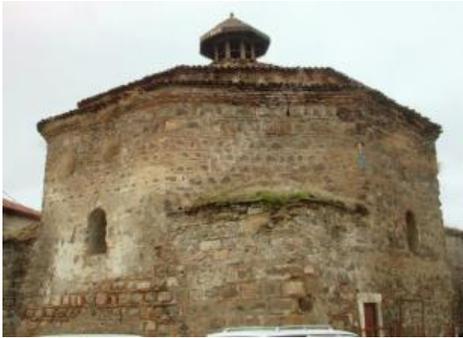
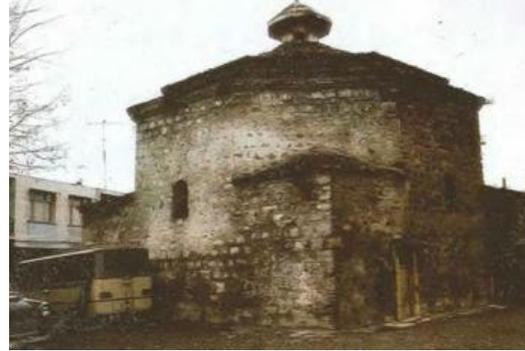
Picture 1. Bath structure before restoration¹⁷. Picture 2. Bath structure before restoration¹⁸

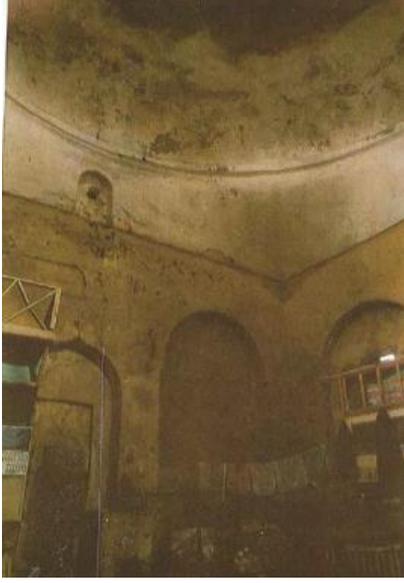
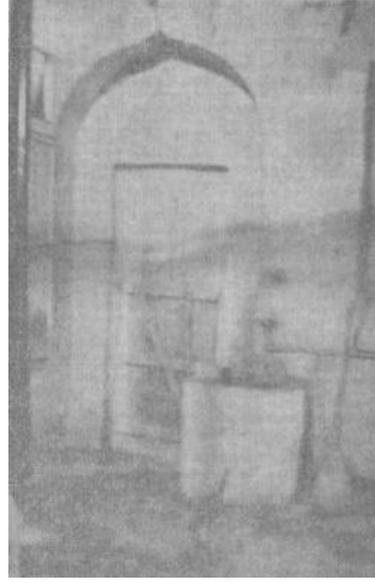
Picture 3. Disrobing area” before restoration¹⁹ Picture 4. “Warm area” before restoration²⁰

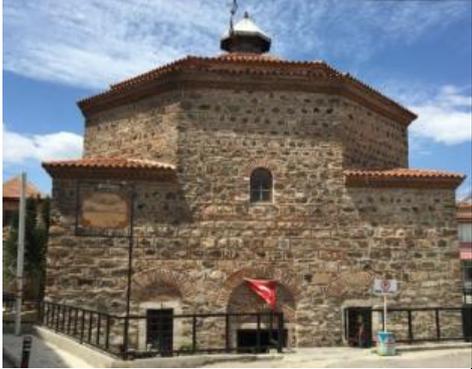
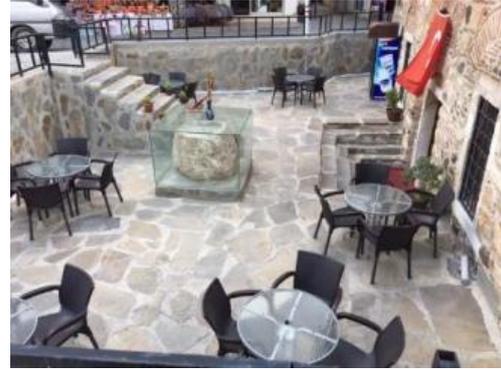
Over the past several centuries, the perimeter of the bath building has been raised. The structure is remained approximately one-half to two-meter of low level. The orientation of the bath is the east-west direction. Brick and stone materials are used in the construction. The walls consist of two rows stones and bricks. Several bricks are arranged vertically between stone rows. The building stone walls are joined with the roof where is placed cross brick lines (kirpi saçak). The arches on the facade are built with bricks.

Picture 5. East Facade of Bath

Picture 6. East Facade of Bath

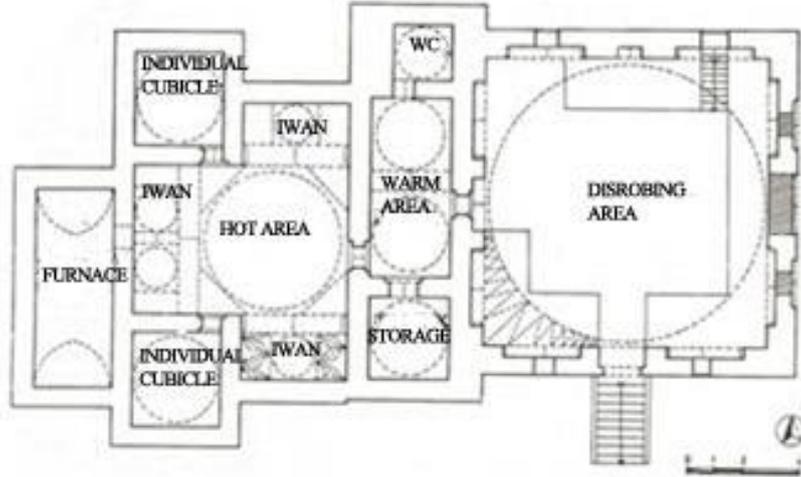
The disrobing section of the Sungur Bey bath covers a square area (Figure 4). The top of the section is covered dome with tambour frame. The lighthouse is at the top of the dome. The transition to the dome is made with Turkish triangles in the disrobing section. The windows and the doors were closed by users that they w converted to their original form after restoration. Separate entrance doors in this section were made for women and men. The entrance gate on the southern side of the bath was made for men. The inscription was located on the southern facade of the structure above the entrance door. The door on the east side was for women to enter.

Figure 5. Schematic function plan of Sungur bey Bath before restoration²²

In the Sungur Bey bath, the warm area's entrance was placed at the western part of the disrobing section. Warm area is rectangular type of plan schemes has two domes (Figure 4). This area has a sitting platforms and bath basins (kurna) side of the walls. In addition, depilatory section, toilet and storage were located near the warm area. These small areas were covered with small domes. Transitions to the domes were provided via pendants.

The hot area is third section which has a big central dome. This section has a cross plan type with three recesses (iwan) and two individual cubicles (halvet) at the sides of the central space. Individual cubicles (halvet) which had bath basins (kurna) for bathing were covered with small dome at the northwest and southwest of the hot area. There was a glass lighting system (fiğözü) on the dome (Picture 12). Pendants, Turkish triangles and muqarnas were used at the domes. In the last section was the furnace (külhan) which was covered with a barrel vault.

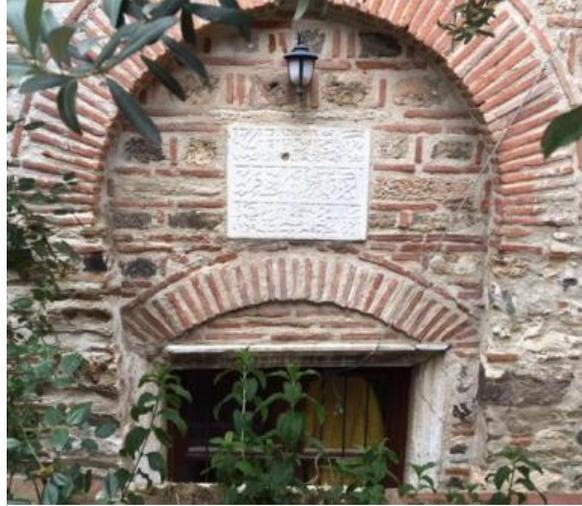
The inscription was located on the pointed arch of the door on the southern façade. It was written Ottoman language (Picture 7; Figure 6).

Picture 7. South entrance

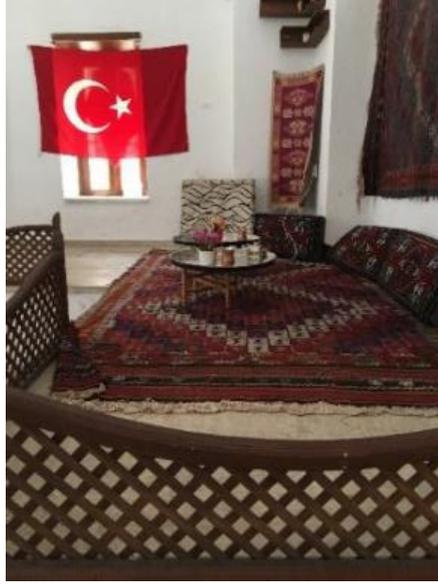
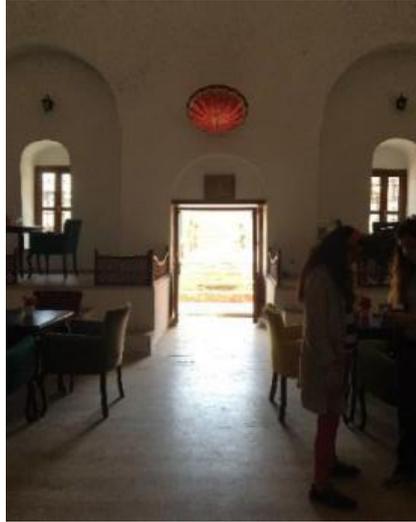
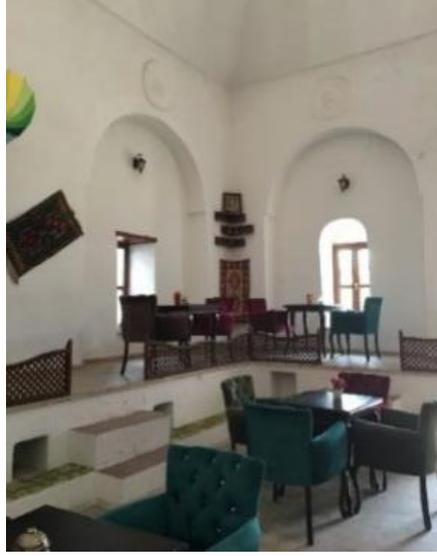
After the renovated of the Sungur Bey Bath, the building is reused as a cafeteria-exhibition building. The entrance area of the building is designed for sitting and exhibiting. The disrobing area of bath is being using for cafeteria function. Tables and chairs are arranged for the users to sit. The disrobing area of bath is converted to sitting areas which consist of different styles of furniture on raised floors (Picture 8; Picture 9; Picture 10).

Picture 8. Spatial transformation of Disrobing area to cafeteria

Picture 9. Spatial transformation of “Disrobing area” to cafeteria

Picture 10. Spatial transformation of “Disrobing area” to cafeteria

Within the scope of the study, after renovation of the interior of the bath were evaluated space performances, conservation and sustainability. It is seen that “cafeteria function” is predominantly used in the building. Due to this function, it seems that a large number of furniture blocks the perception of the interior of the structure.

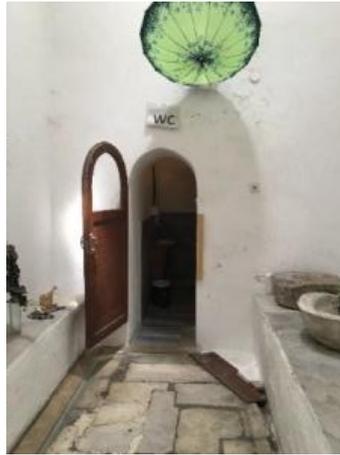
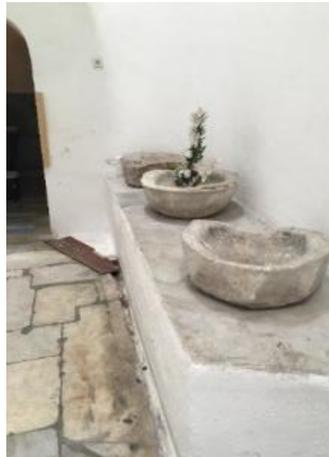
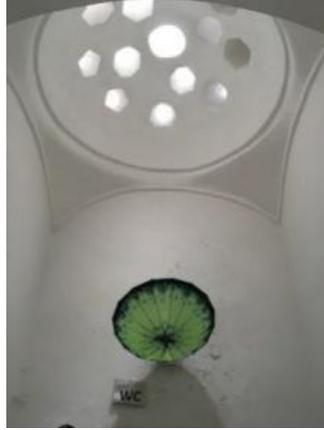
In the warm area, the toilets are still used with their original function. Depilatory area which used in the historical building was turned into storage. Main warm area is used as a sitting area. At the same time, bath basins, some of the Turkish bath furniture and copper vessels belonging to the Ottoman periods are exhibited (Picture 11; Picture 12; Picture 13).

Picture 11. Spatial transformation of “warm area”

Picture 12. Spatial transformation of “warm area”

Picture 13. Dome of “warm area”

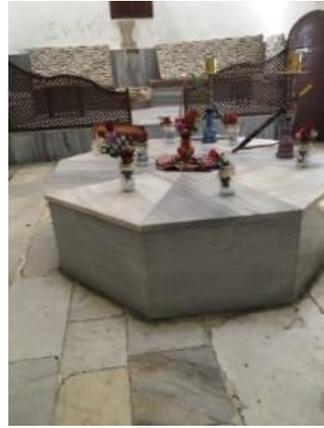
Picture 14. Marble slab in “hot area”

The hot section of the building is renovated as a cafeteria and an exhibition area. The marble slab is used as an exhibition object in the middle of the hot area (Picture 14). The recesses (iwan) are used as a sitting area (Picture 15). Bath basins (kurna), Ottoman Period of bathing objects and Ottoman hookahs are exhibited in this section. Sections of individual cubicles (halvet) are used as a kitchen and storage (Picture 16). The doors and windows on the exterior facades are restored to their authentic shapes after the restoration of the Sungur Bey bath.

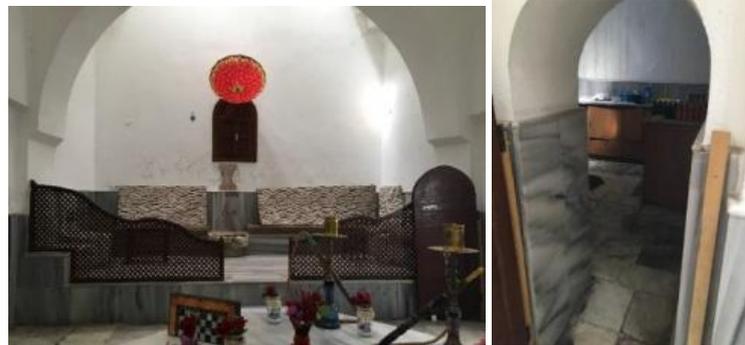
Picture 15. Recesses (iwan) in “Hot Area”” Picture 16. Individual cubicles (halvet) in “Hot Area

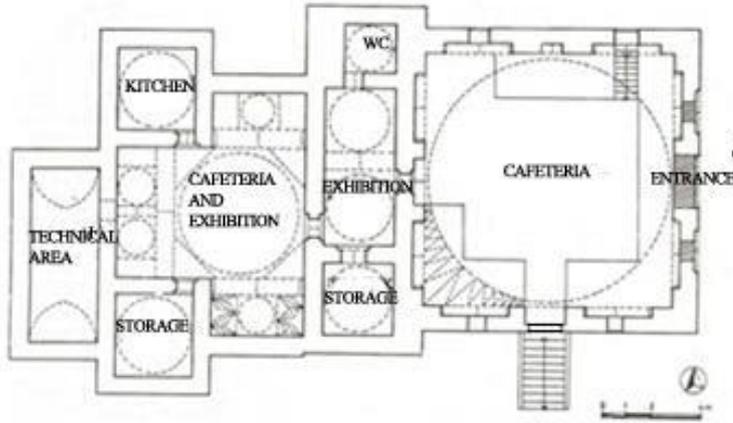
Figure 7. Schematic function plan of Sungur Bey Bath after restoration
